**Rio Grande Watershed
Emergency Action Coordination Team**
Hinsdale County • Mineral County • Rio Grande County
Colorado Water Conservation Board
www.rweact.org

Rio Grande Water Quality Monitoring: The First Summer After the West Fork Complex Fire

September 21, 2014

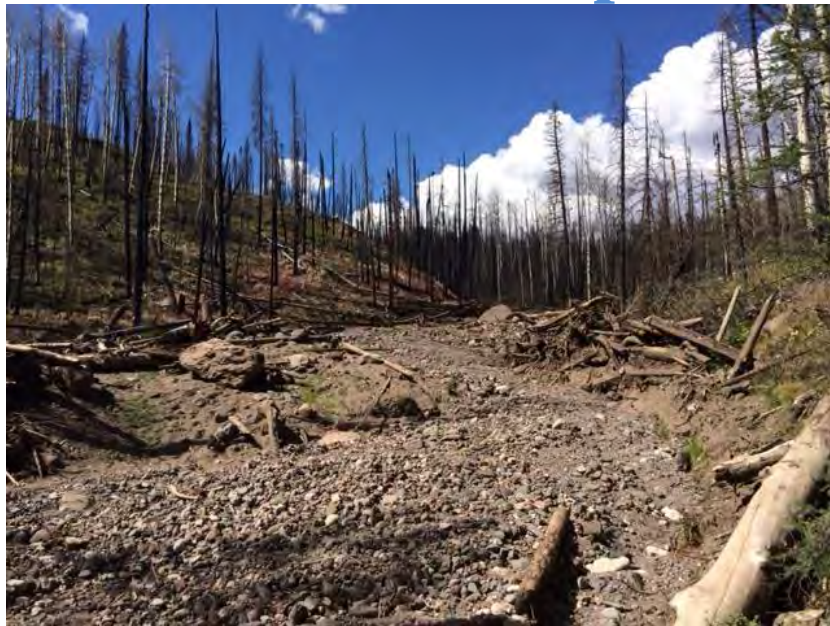
Trout Creek debris flow

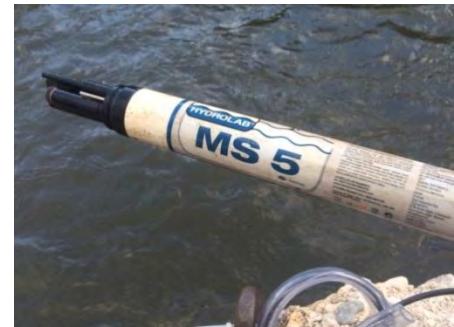
Figure 1. Hydrolab MS 5 multiprobe sonde. This is the sonde at the Marshall Park site on the Rio Grande.

In order to monitor the water quality in real-time, six Hydrolab MS 5 sondes purchased by RWEACT were deployed at the six Rio Grande study sites (Figure 1). The sondes are a bundle of five probes set up to test, record, and transmit data every fifteen minutes. The Hydrolab MS 5 sondes have interchangeable probes. For this study the five probes on the sondes measured water temperature, pH, dissolved oxygen, conductivity (specific conductance), and total dissolved solids (TDS). Five of the sondes were wired into the CDWR gaging stations for both electrical power and transmission of the data over the internet. The sixth sonde, at Thirty Mile, was separated from the gaging station to gain the appropriate distance from the burn scar so as to function as a true control measuring water quality in the Rio upstream of the burn. Due to location the sonde at Thirty Mile was not connected to the CDWR website. The sondes were set-up in temporary shelters (PVC pipes) anchored to structures (a rock or a bridge) in order to be left out for the duration of spring and summer. The sondes were deployed in April, right as the ice in the river was melting and have been removed to prevent freezing. Every two weeks the sondes were checked and calibrated.

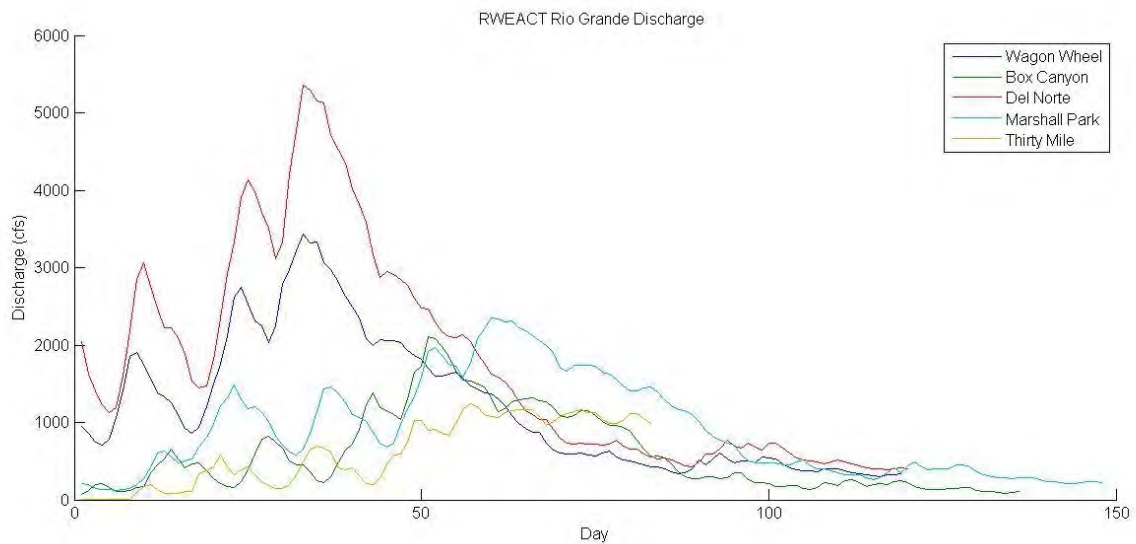
Figure 2. Stream discharge at each of the six RWEACT water quality monitoring sites along the Rio Grande. Day 0 was April 3, 2014, the first day that the Hydrolab MS 5 was deployed at each site, day 150 was August 31, 2014.

The six Hydrolab MS 5 sondes that were deployed along the Rio and were taking continuous readings show a healthy river. From this data, the Rio appears to be a resilient river, thriving after a dramatic fire. The river flow, or discharge, follows the expected trend of a mountain river, where the majority of the discharge comes after the snowmelt in spring and the flows steadily decline throughout the summer (Figure 2). The stream temperatures, as recorded by the sondes, also show a normal river where the temperatures get warmer through the summer but do not exceed the threshold for aquatic life of 20°C (Figure 3). The control site, Thirty Mile, does appear to be cooler than other stations, but it is also the furthest upstream and the most shaded site (Figure 4). The pH at each site was circumneutral (between 7-9) and appears to be unaffected by fire (Figure 5). Once again the control site appears lower, but that is likely due to probe abnormalities (Figure 6). Other sites show irregular pH's periodically, but again this is due to probe malfunctions and conditions around the probe. The dissolved oxygen (DO) concentrations at each of the six Hydrolab MS 5 sites all stayed within normal range, when they were functioning properly. Dramatic drops in the DO graph lines are due to mud accumulation and entrapment around the probes (Figures 7 & 8). Conductivity and total dissolved solids are measures of dissolved materials in the water, including charged ions and organic constituents. The conductivity and total dissolved solids along the Rio were normal until a hillslope slide along Hope Creek occurred on July 9 that sent mud down the South Fork of the Rio and on to the Rio Grande at Del Norte around days 90-100 of the study (Figures 9-11). A fish kill on the South Fork of the Rio was reported at this same time and there was evidence of fish kills in the weeks that followed (Figure 14).

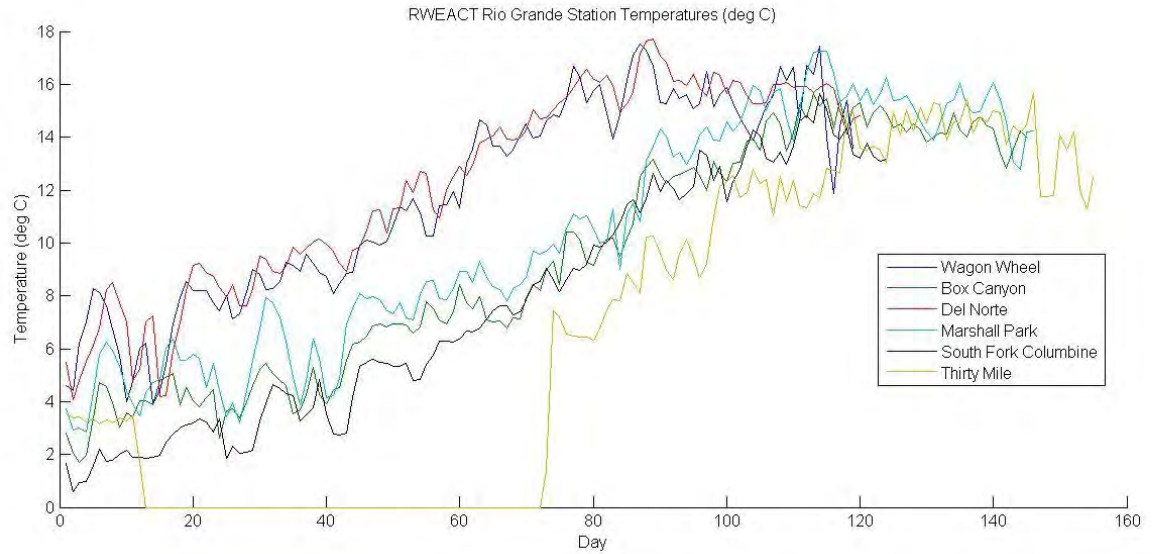
Figure 3. Stream temperature data from each of the six Rio Grande study sites from April 3- August 31, 2014.

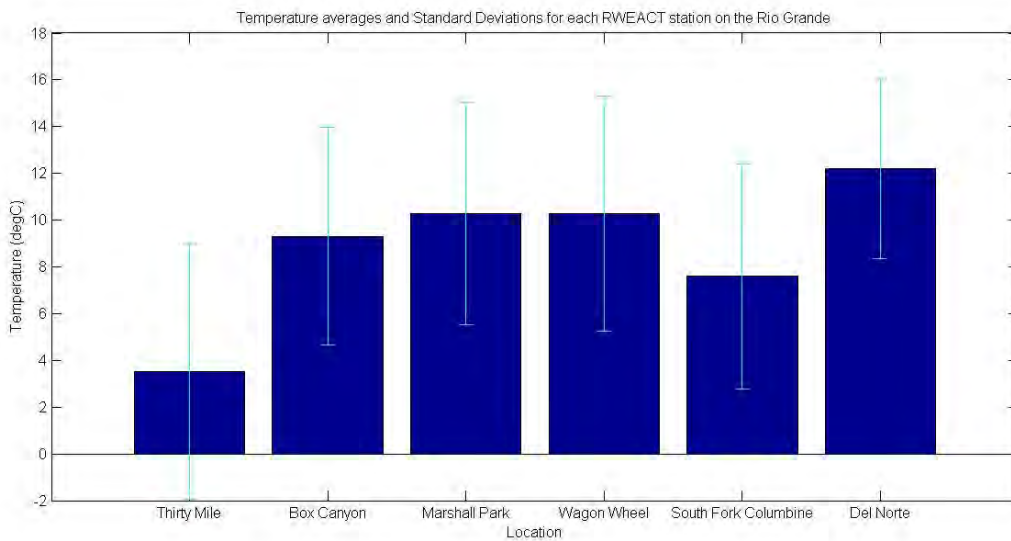
Figure 4. Stream temperature averages and standard deviations at each Rio Grande stations.

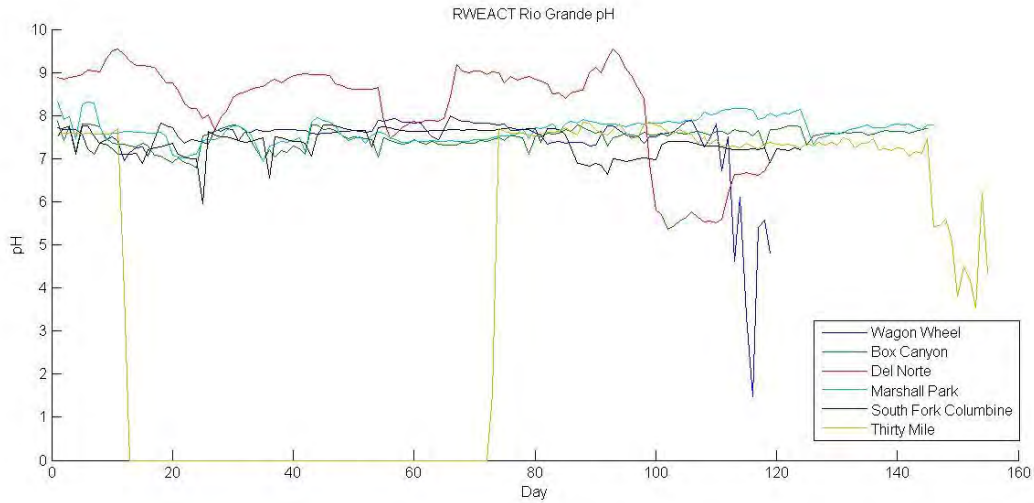
Figure 5. pH at each of the six Rio Grande study sites from April 3, 2014 to August 31, 2014. Anomalies in the pH data shown here were due to local conditions around the probe and are not true water quality abnormalities.

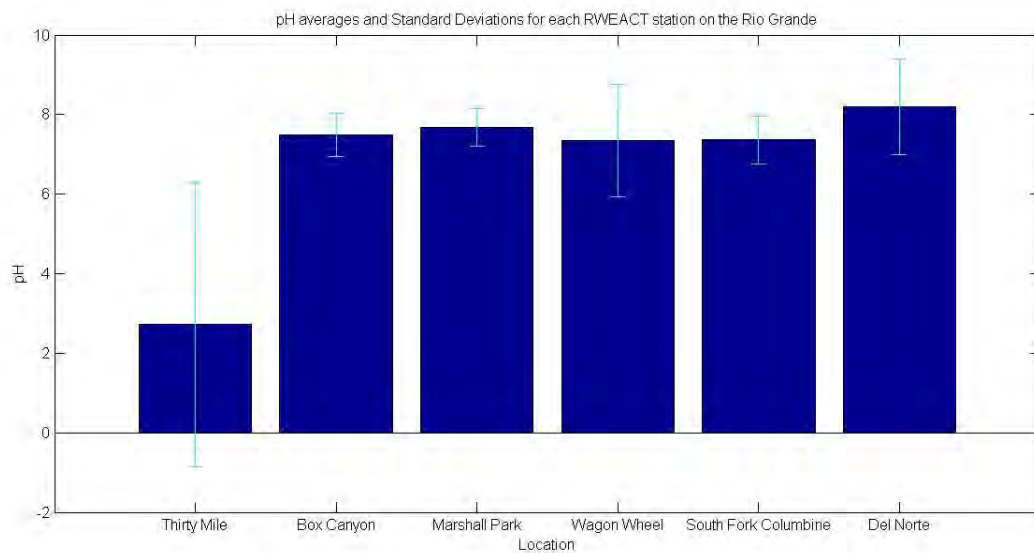
Figure 6. pH averages and standard deviations from Hydrolab MS 5 data at each site on the Rio Grande. Thirty mile pH is dramatically lower, but this is due to some probe malfunction.

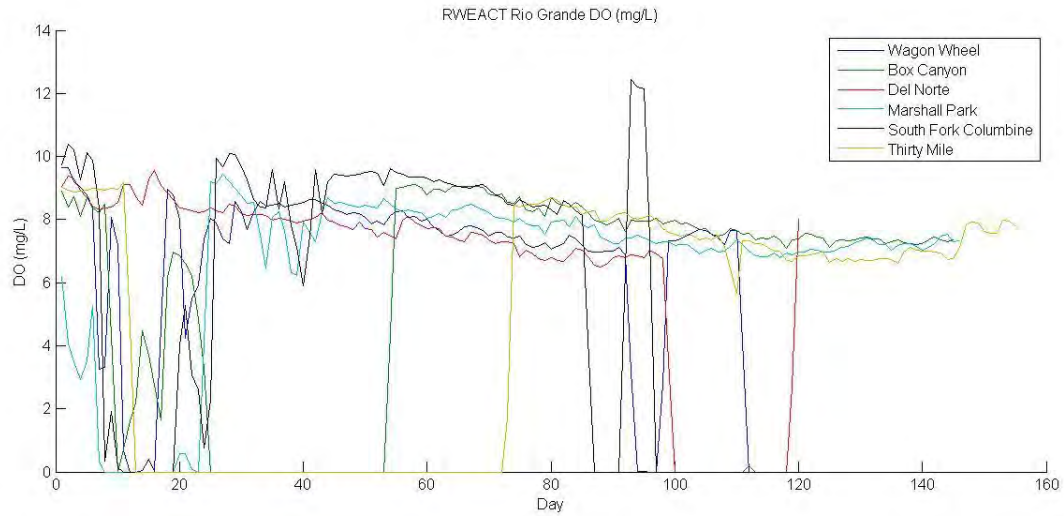
Figure 7. Dissolved oxygen concentrations at each of the six Rio Grande RWEACT water quality monitoring sites. Again, the dramatic drops in the dissolved oxygen in this figure have more to do with poor probe conditions than with water quality issues. When probes functioned properly, dissolved oxygen concentrations stayed within the normal range of 6-8 mg/L.

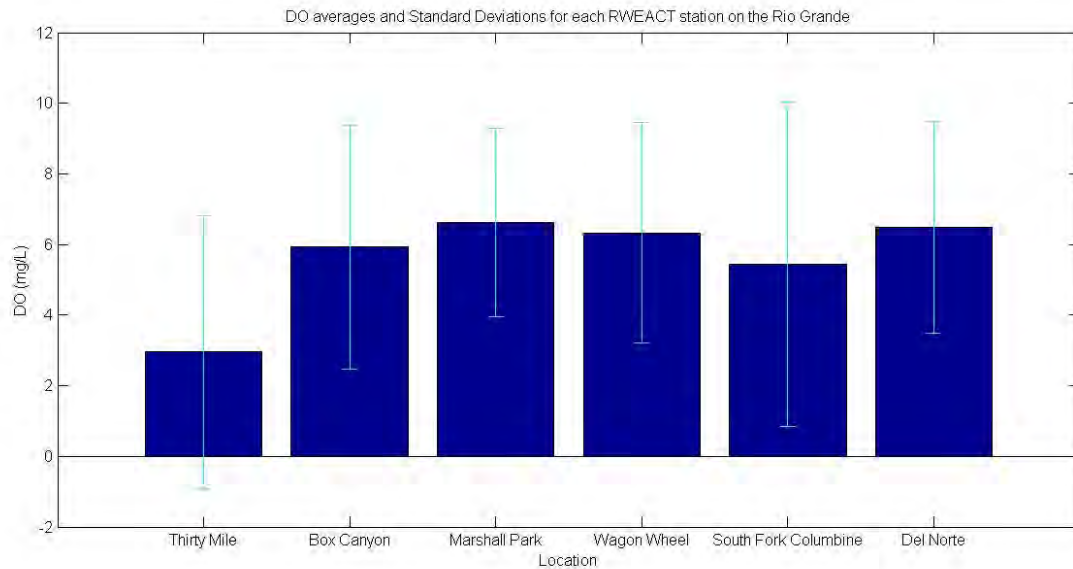
Figure 8. Dissolved oxygen averages and standard deviations at each of the Rio Grande sites.

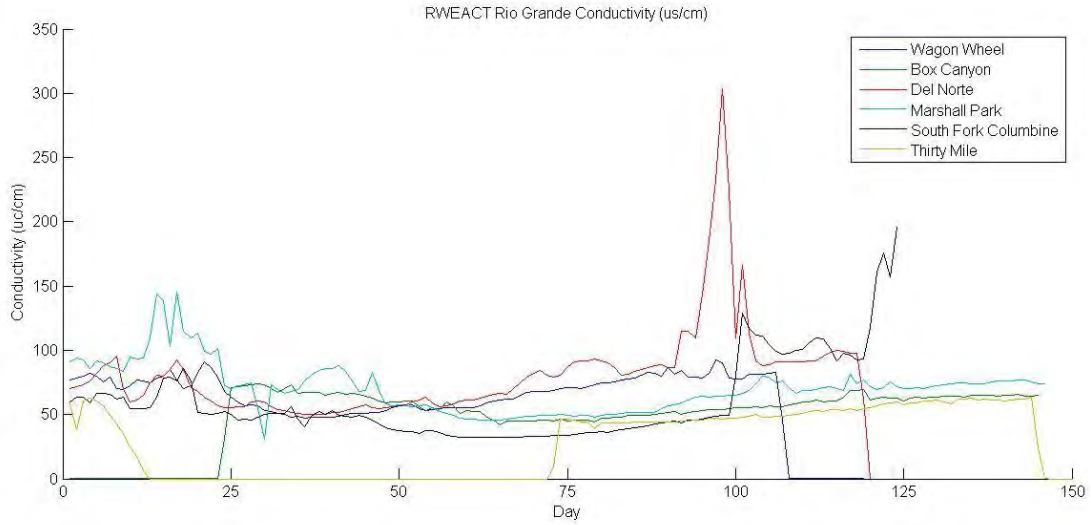
Figure 9. Conductivity values, in terms of specific conductance, at each of the six Rio Grande sites. Spikes in the conductivity correspond with a high mud flow event that took place on the S. Fork of the Rio on July 9. Here a spike in the conductivity at the S. Fork site was followed two days later by a spike at the downstream, Del Norte site.

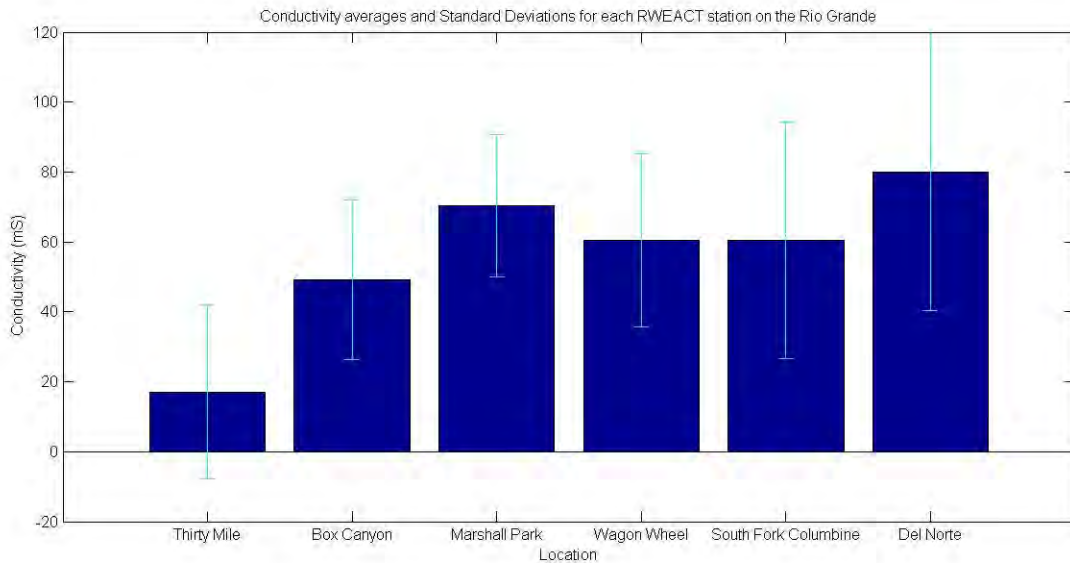
Figure 10. Conductivity averages and standard deviation at each Rio Grande sites.

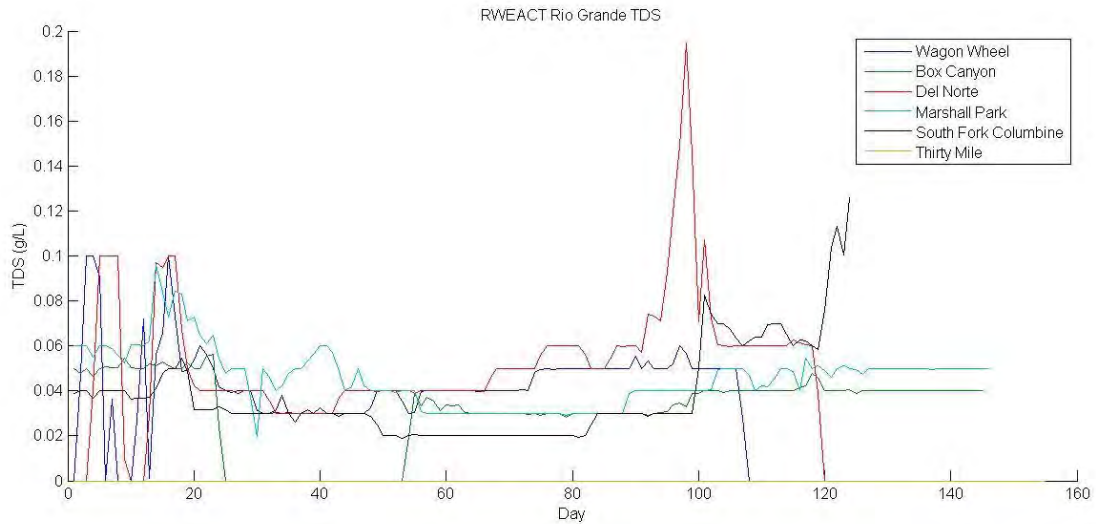
Figure 11. Total dissolved solids from each of the six Rio Grande RWEACT sites. Once again the early season data shows odd anomalies due to problems with the initial set-up of the probes where the later spikes that occurred on the S. Fork of the Rio followed by a spike at Del Norte are likely due to a landslide event occurring on Hope Creek before it merges with the S. Fork of the Rio Grande.

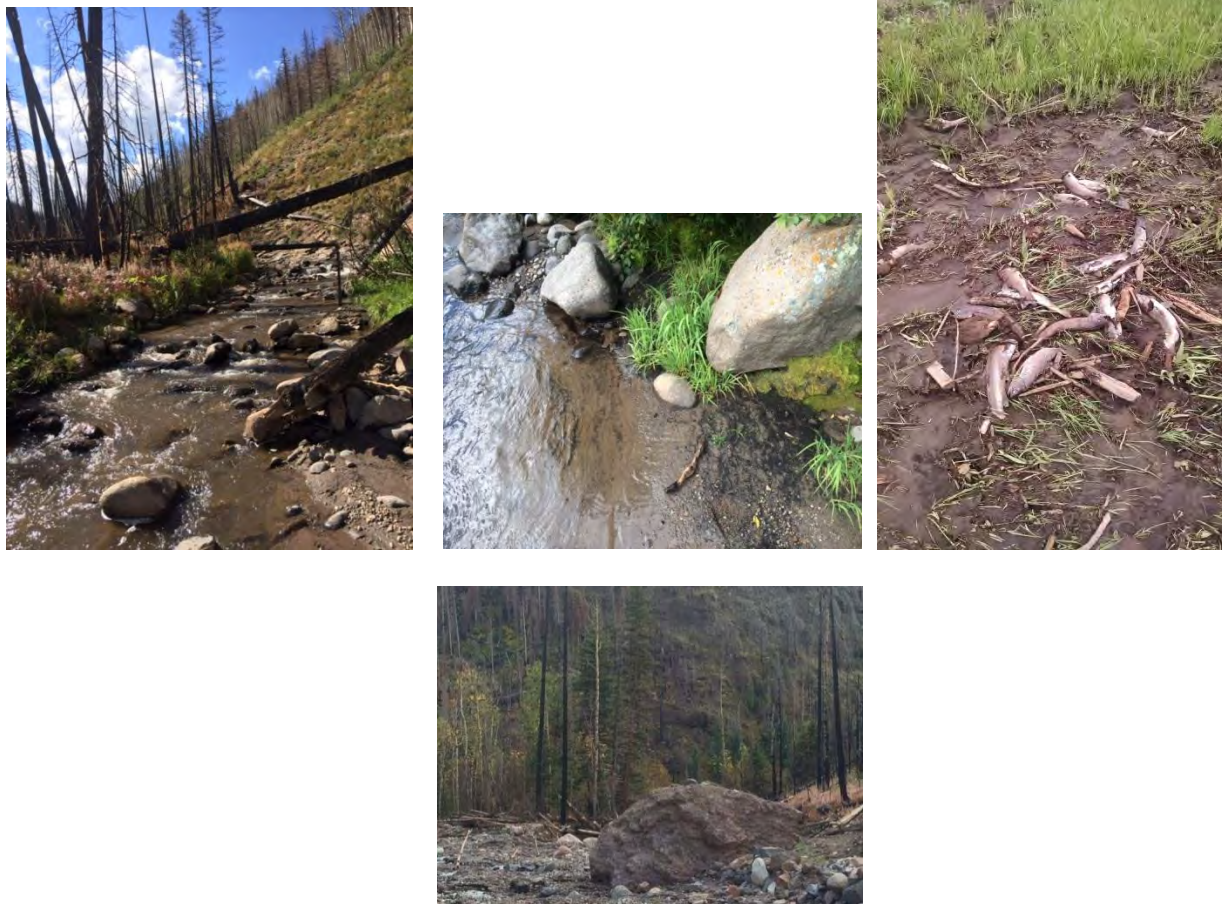
Figure 14. Hope Creek in the burn area on the top left with brown turbid water, ash and sediment deposit in the S. Fork top center (9/9/14), a fish kill on Trout Creek on the right (8/4/14), and a boulder in the debris flow on Trout Creek on the bottom center (9/20/14).

The most interesting and remarkable water quality signal was the elevated concentrations of total suspended solids and turbidity in burned tributary sites and Rio Grande below where these tributaries converge with the Rio (Figure 12 & 13). The Rio Grande at Marshall Park is below the confluence with Trout Creek, another tributary that had a hillslope slide and subsequent debris flow and erosion after monsoon rains, this event happened on August 4. Several days of monsoon rains likely saturated the burned slopes and caused the steep slopes to move. The sediment inundated the creek with mud and choked fish, leading to a dramatic fish kill (Figure 14).
